## SURVEY REPORT No: H14-531

### "STORM VOGEL"

While she was on the hardstand at Norship Marine, Cairns, Australia on the 03-11th July 2014, to ascertain the cause and nature of failure alleged to have occurred to a seawater seal on the swing keel on the 22/06/2014 at position 159.02 East and 16.20 South.

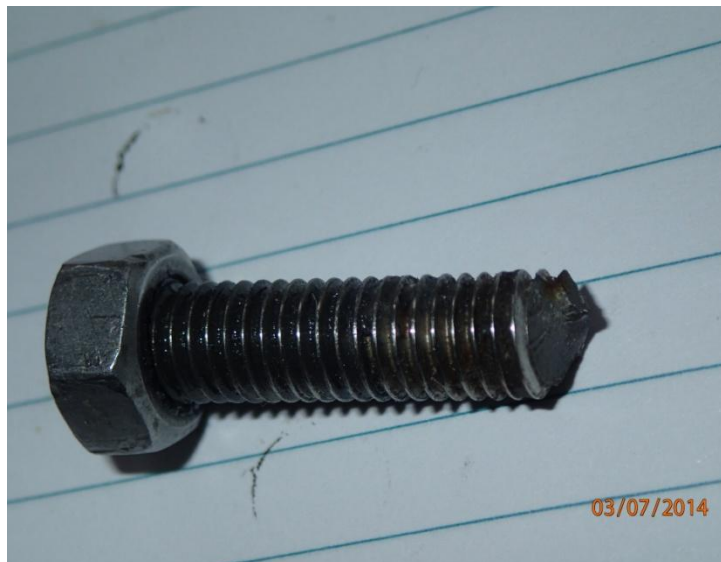
3.1 On my initial attendance on the 03/07/2014, it had been found by Norship Marine engineers that Storm Vogel swing keel shaft seal carrier had four (4) x eight (8)mm stainless steel studs to bolt the seal carrier to the housing. Three (3) of these studs had sheared with one (1) on the aft bottom side remaining intact.

Original broken stud

5.4 In turn this would cause contact of the shaft and the starboard side seal carrier to shear the three (3) retaining studs, allowing water to enter the vessel.

3.4 The broken ends of the retaining studs in the housing could not be removed due to accessibility and four (4) new holes had been drilled and tapped.

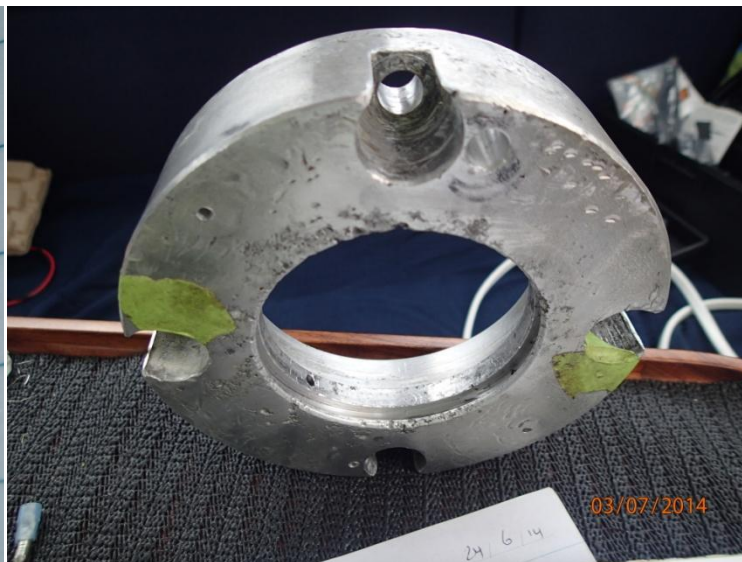
Original seal carrier

3.2 There were no apparent impact markings on the seal carrier to swing keel shaft face of the aluminium or the O ring fitted from visual inspection with the aid of a magnifying glass.

3.3 Norship had manufactured a new seal carrier to the same dimensions as the original including the O ring modification and grease nipple as done by Norsand in New Zealand.

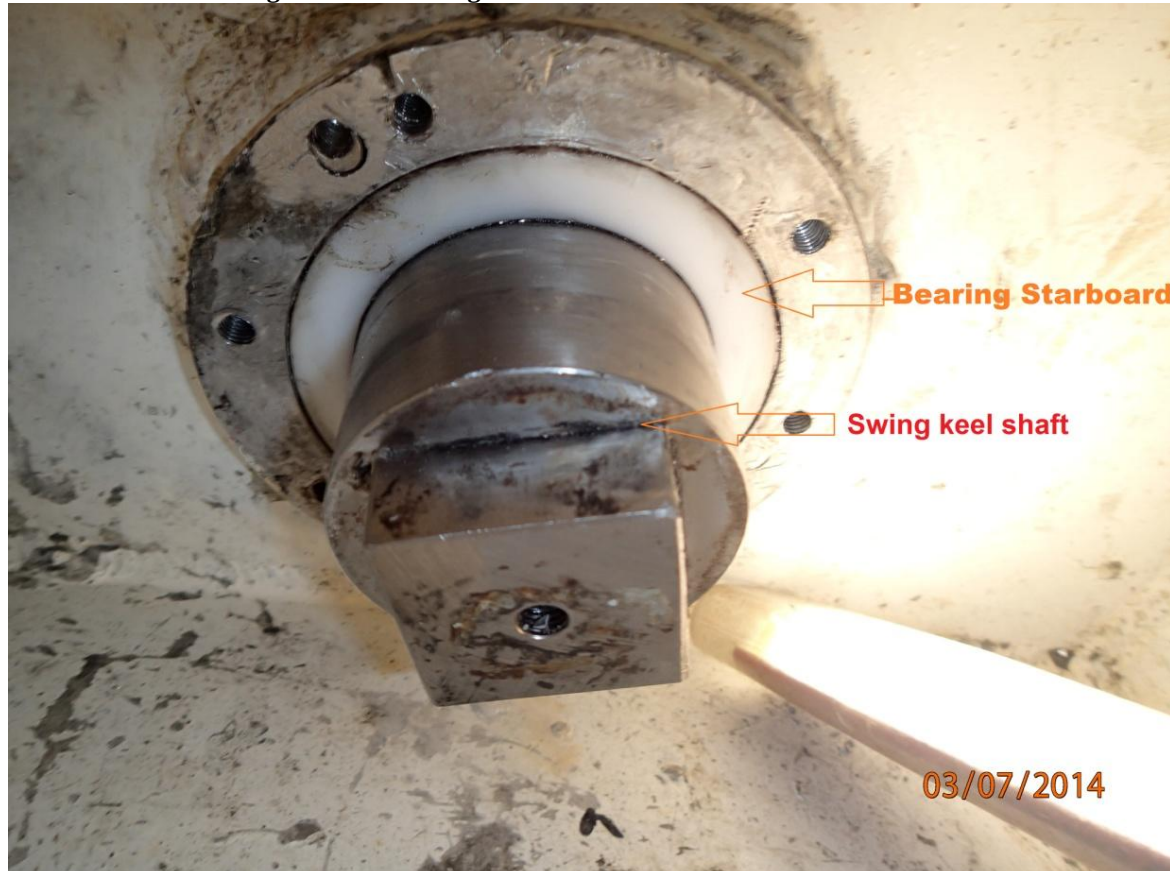
Starboard view of swing keel shaft arrangement

3.5 The new seal carrier was then reassembled for testing. Storm Vogel was lifted and the swing keel extended on the 04/07/2014 with myself attending. There was movement detected between the swing keel body and the shaft by looking up between the swing keel and casing. It was then decided to remove the entire swing keel for analysis.

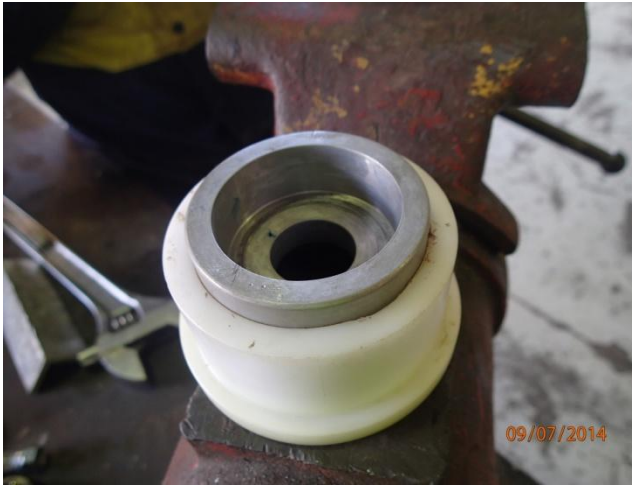
3.6 During removal of the swing keel it was found the retaining nut holding the bearing spigot on the port side (item 4 at appendix B) was loose and the bearing spigot had slipped diagonally onto the thread causing the shaft to drop and difficult to remove.

**Port bearing spigot inside bearing**

5.3 In my professional opinion, this has most probably worked the retaining nut on the port side bearing spigot loose over time, allowing the spigot to misalign on the shaft and subsequent misalignment of the shaft in the bearing.

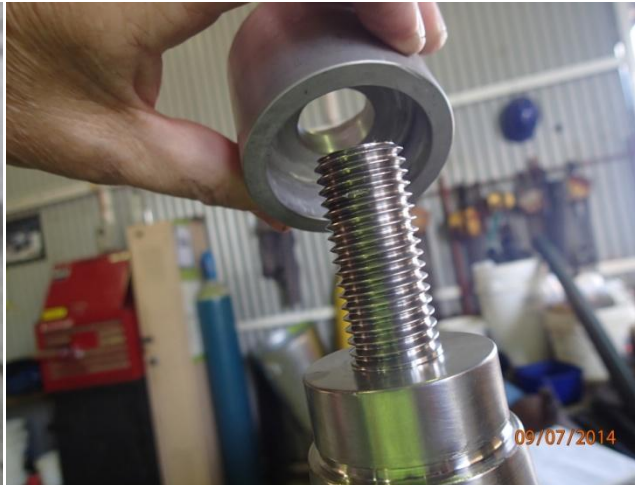
**View of port side of shaft and bearing spigot**

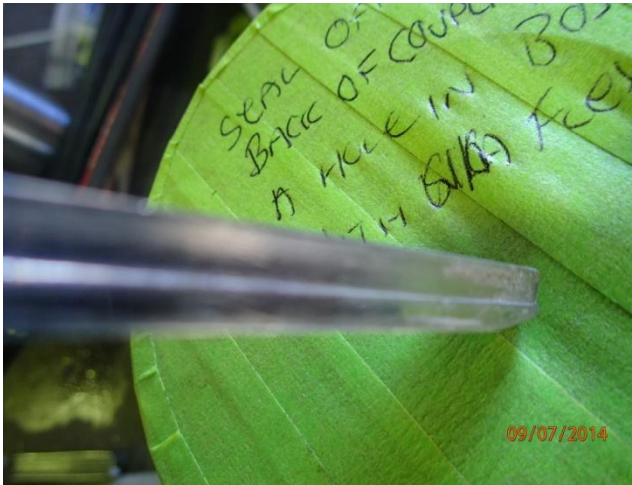
3.9 The swing keel shaft fits into the swing keel on a taper with a keyway and key. The key was found extremely worn with both sides of the key worn concave and a clearance of 1.5mm in the keyway.

Key showing concave wear

3.9.2 This is consistent with the key rolling inside the keyway, causing pressure on the shaft taper on one area and the wearing of the key concave and edges of the keyway in the swing keel to wear down.

3.10 A new keyway and key were cut from the original 14mm to 16mm. New bearings were manufactured and the shaft taper scrape fitted to 80% + fitment. The swing keel was then refitted to Storm Vogel and tested satisfactorily.

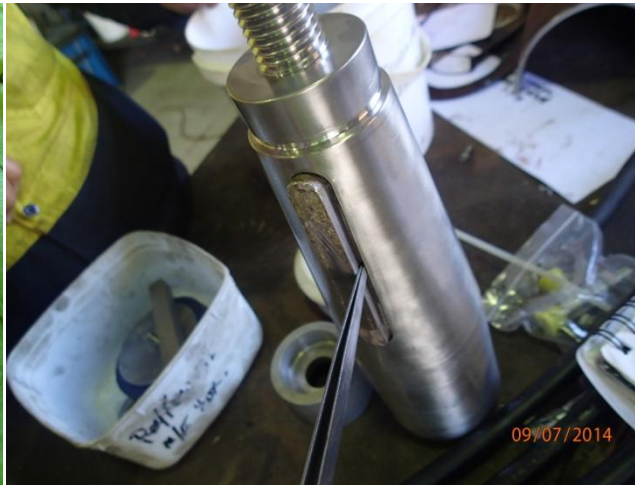
Clearance of key in keyway

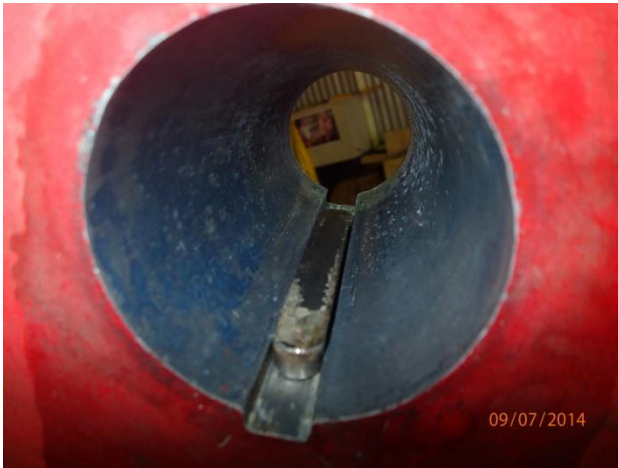
3.9.1 The taper was fitted with bearing blue into the swing keel and fitment was less than 30%. The contact area was on one side of the housing, approximately 60 degrees around from the keyway.

**Key fitted in swing keel keyway**

5.1 From the wear and fitment apparent the key has been moving in the swing keel keyway for a considerable period of time.

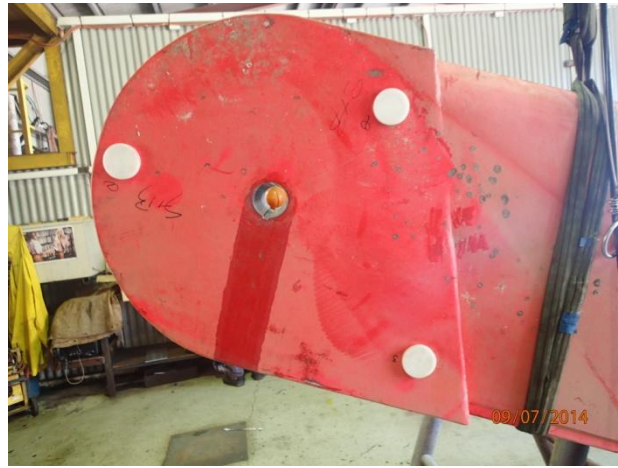
**View of swing keel top with shaft housing central**

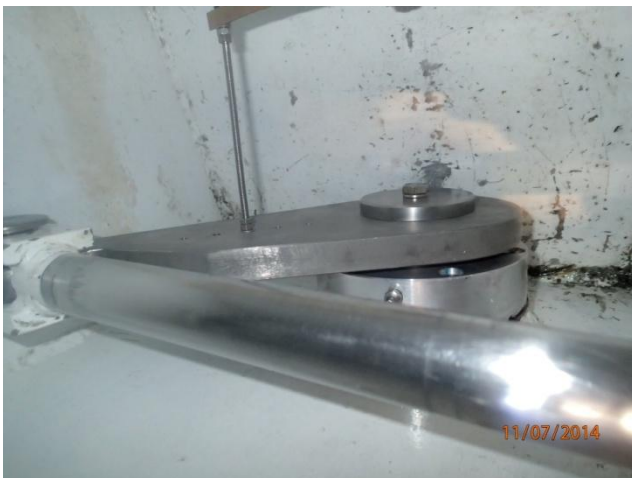
**View of starboard side of assembled swing keel shaft and hydraulic ram**

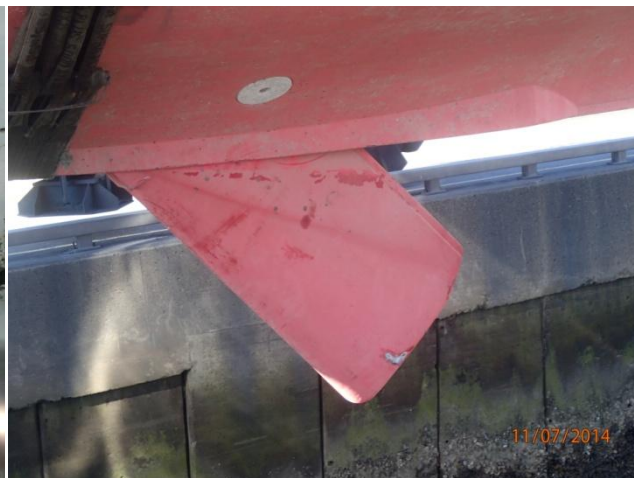
**View of swing keel during retesting**
