22 January 2015

Ref. sv Stormvogel Swing Keel

## S.V. STORMVOGEL SWING KEEL

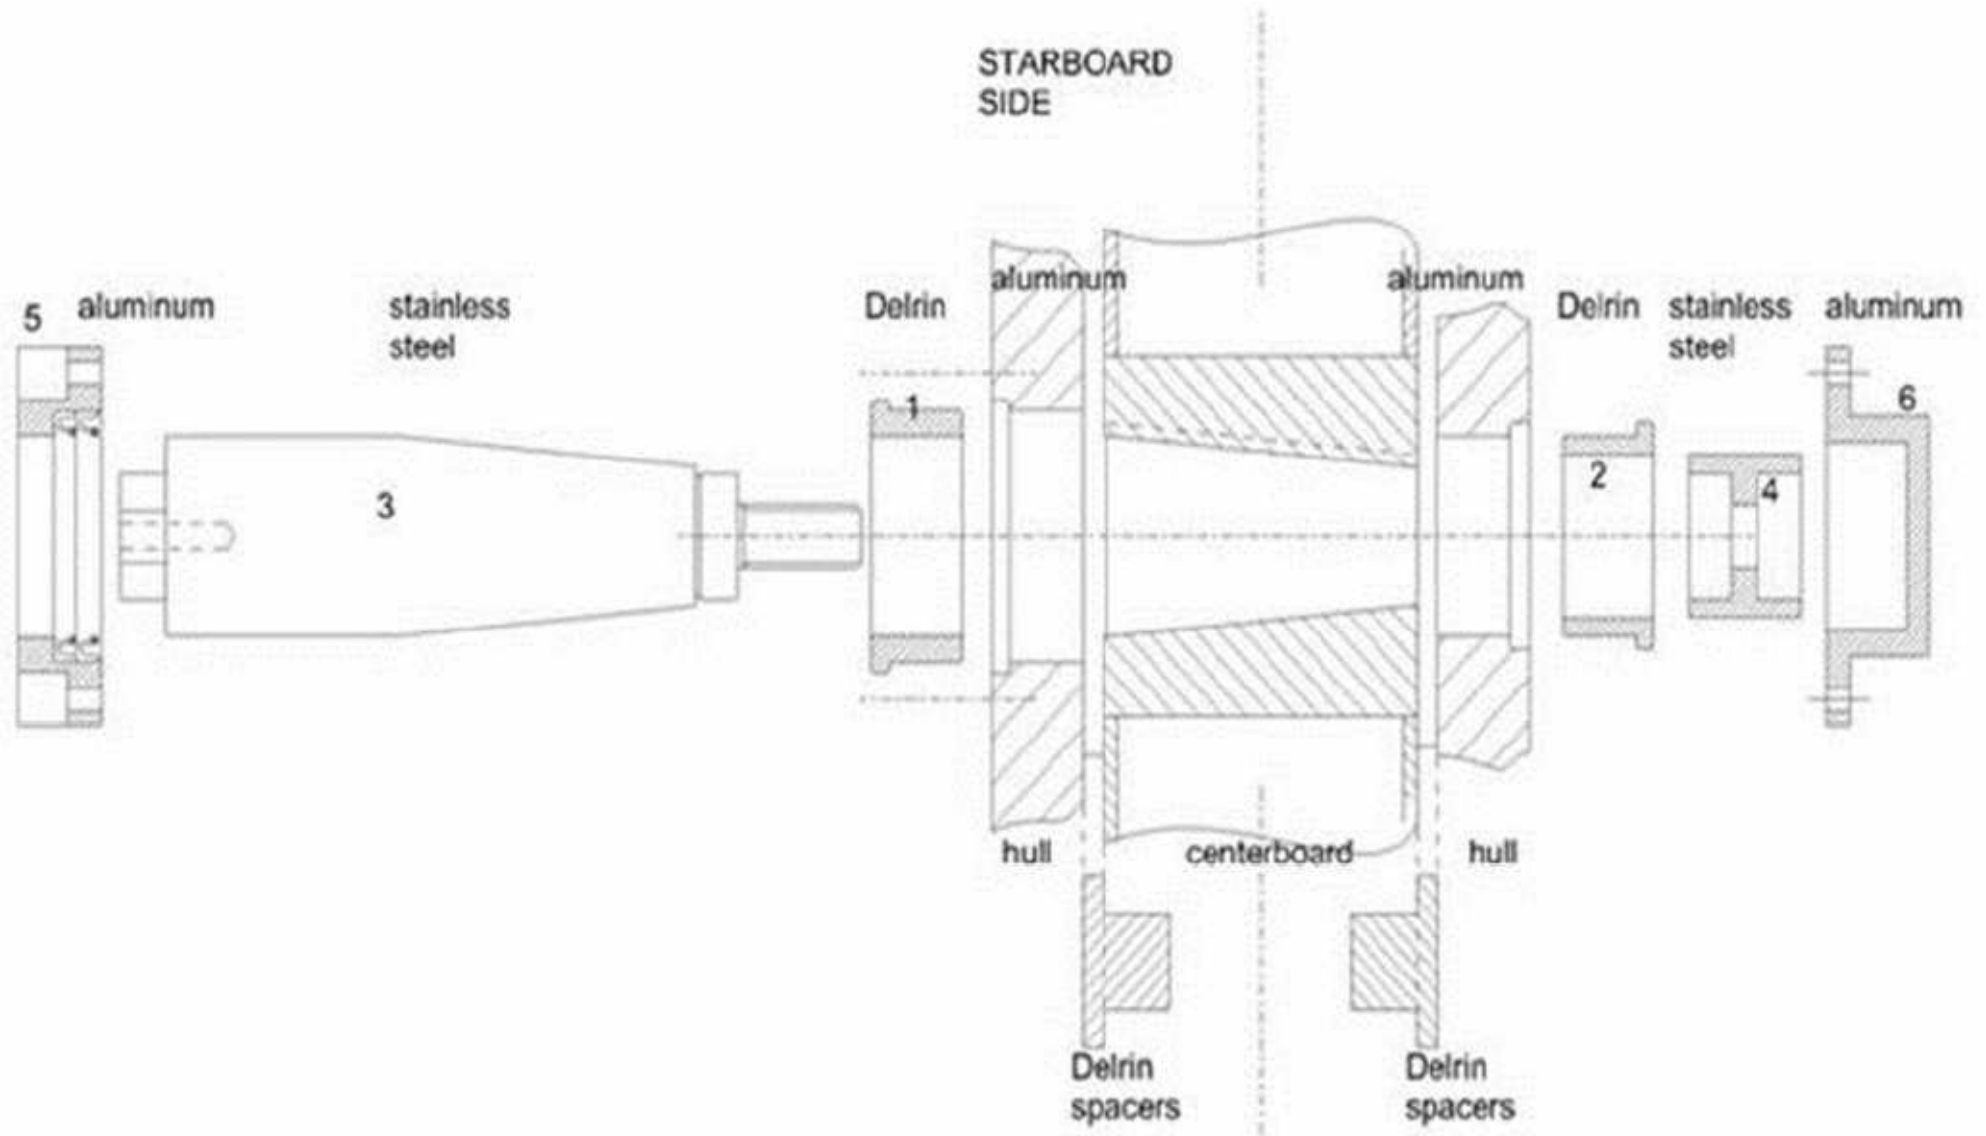
## Annex A - Exploded sectional drawing of swing keel components

At the opposite, starboard end, of the pivot shaft is the seal carrier, item 5, attached by four Ø8mm threaded studs into tapped, blind holes in the aluminium keel box. The sealing arrangements comprise a gasket between the seal carrier and keel box and a pair of lip seals fitted in a recess on the inboard side. A Ø6mm 'O' ring is shown in red in the Annex B drawing, but does not appear in the Annex A exploded view, and is reported to be a modification carried out by Norsand during a refit in early 2014.

There is no collar on either the starboard side of the pivot shaft or the bearing spigot i.e. the shaft is fully floating axially within the Delrin bearings (items 1 & 2). The only restraint on axial movement of the shaft is the two Delrin spacers shown in Annex A only, and three spacer pads on the outside of the swing keel seen in Ref. (1), S3.9.2 - right hand photograph.

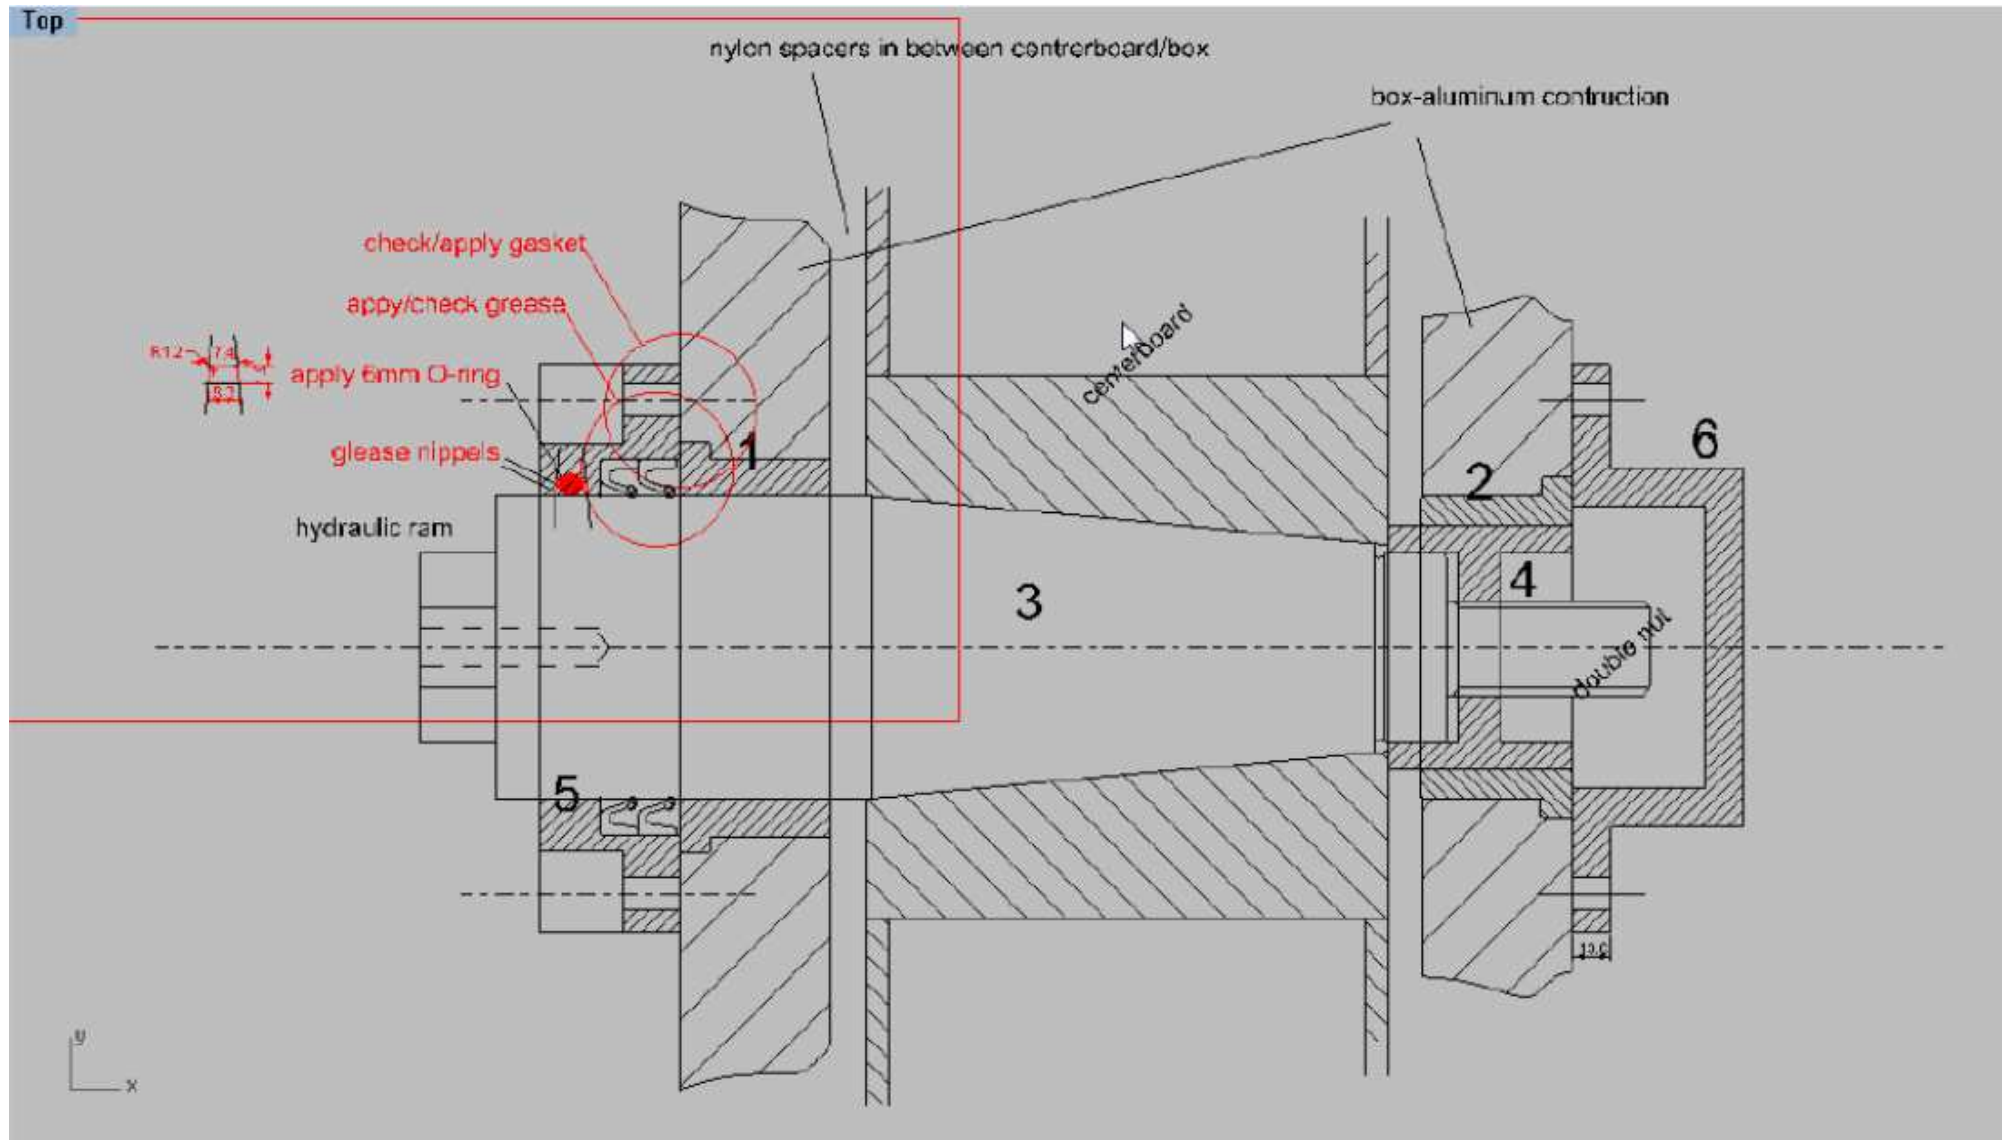
## Annex B - Assembled sectional drawing of swing keel components

On the port side of the shaft (right side of the drawing) is a threaded spigot about Ø24mm in diameter and 50mm long, of which about 35mm of thread is exposed when assembled into the bearing spigot (item 4). A pair of locking half-nuts about 17mm or less in depth engage the thread to pull the shaft and swing keel tapers together; one of these nuts fits fully within the 18mm deep recess of the bearing spigot, with the other on top but above the recess. The dimensions noted were scaled as accurately as possible from the Annex B drawing with reference to the known 8mm diameter studs attaching the seal carrier.

There is no indication from either the Annex A or B drawings as to which type of fastening is correct.

- Mr. Howells' reference to the loose 'retaining nut' (singular) suggests that there was only one nut fitted. The Annex B drawing indicates a double nut at the starboard end of the pivot shaft in the manner of paired lock nuts intended to provide security against spontaneous slackening off.

As with any other keyed, taper drive system, it is critical in assembling the pivot shaft and bearings that the two half-nuts are positively locked together to keep the taper bores and key/keyways in tight contact. Some difficulties are foreseen in doing this in practice. Since the first half-nut fitted is buried to approximately full depth within the recess in the bearing spigot (item 4), a special tool – cranked 'C' spanner or similar, may be required to hold it secure while fitting and torqueing up the second half-nut. When assembled, the two half-nuts should ideally be mechanically locked together with a pin or drilled and tapped to take a locking screw.

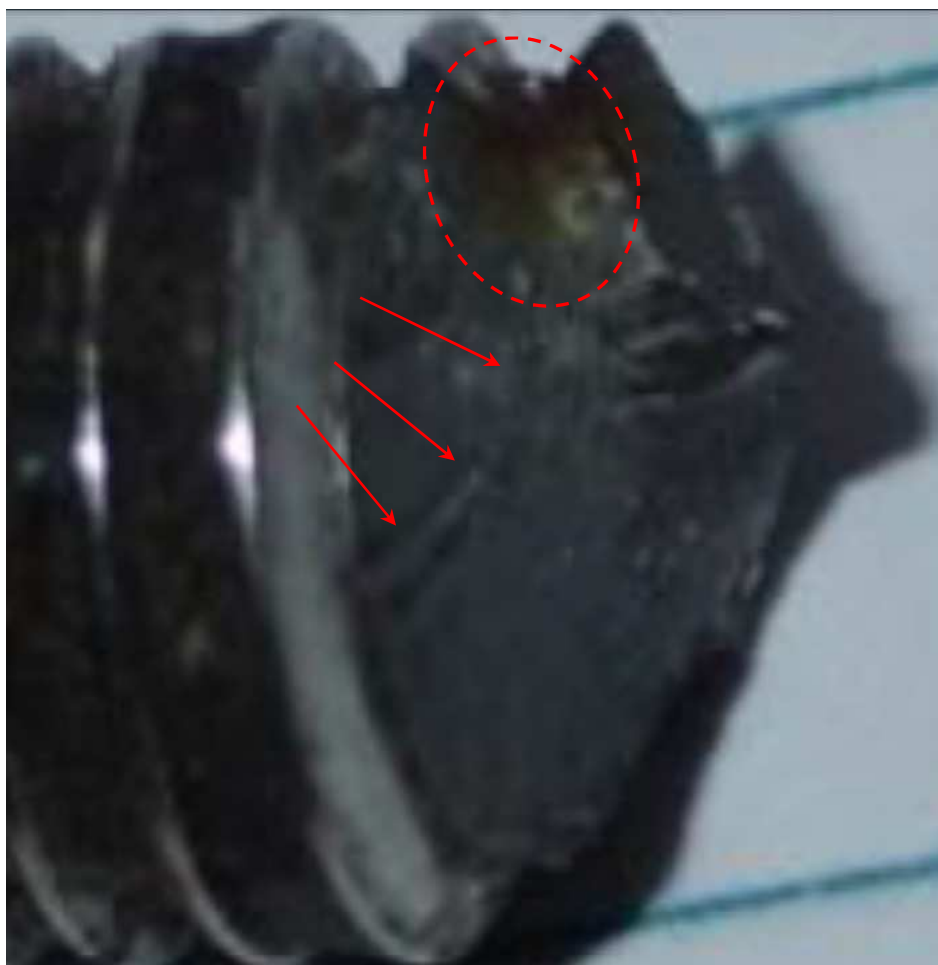
## Annex C

The photograph at S3.1 of the survey report shows one of the three broken studs, with about 20mm of thread remaining to the left of the broken end. This appears to be a commercially mass produced fastening with a rolled thread as distinct from a custom made die- or machine-cut thread. Approximately 14mm of thread would have been inside the seal carrier body with the point of failure being about 6mm inside the keel box.

The photograph is of reasonably high quality and resolution and has been digitally expanded, as shown at Annex C below, to inspect the fracture face. At the top centre, within the red circle, some brown 'tea staining' is evident at the root of the thread. Below the circle are three arrows highlighting what appear to be concentric, circular beach marks, typical of bending fatigue fracture where the lines radiate out from the point of initial failure. The tea staining is most likely the result of chloride contamination initiating crevice corrosion within a small surface flaw which has propagated into a crack, ultimately leading to failure.

Increased side movement of the keel, if excessive or prolonged, may be expected to put cyclic bending moments on the seal carrier fastenings, three of which eventually sheared through unidirectional bending fatigue. At that point the seal carrier would be attached by only one stud providing a copious leakage path between itself and the keel box by-passing the lip seals.

Expanded close-up view of fracture face of seal carrier broken fastening, shows:-

Tea staining within circled area;

Beach marks radiating from origin point of failure
