## SURVEY REPORT No: H14-531

### "STORM VOGEL"

While she was on the hardstand at Norship Marine, Cairns, Australia on the 03-11th July 2014, to ascertain the cause and nature of failure alleged to have occurred to a seawater seal on the swing keel on the 22/06/2014 at position 159.02 East and 16.20 South.

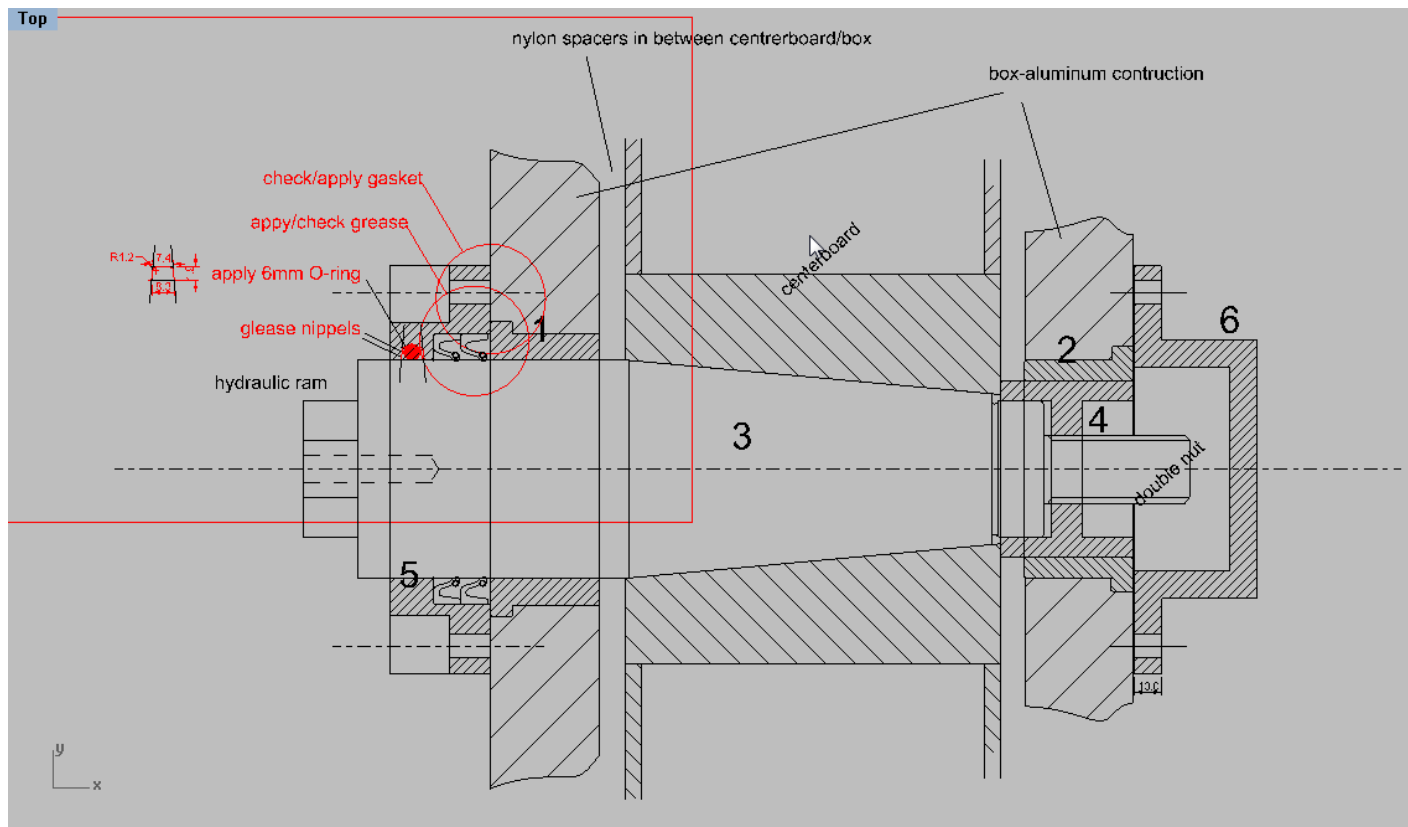
## Appendix B:

3.6 During removal of the swing keel it was found the retaining nut holding the bearing spigot on the port side (item 4 at appendix B) was loose and the bearing spigot had slipped diagonally onto the thread causing the shaft to drop and difficult to remove.
